# Manhole Inspection Summary

Manhole # S23MM1001MH

Insp Date: **11/2/06 11:36 AM**

**Location** Address: **4501 DEER RIDGE DR**

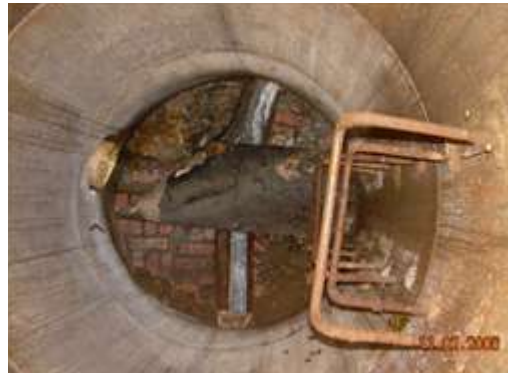
Top View

Bench and Channel debris.

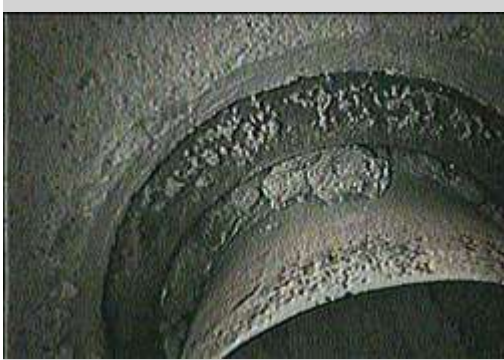
I9 Pipe seal

Comments **The I9 pipe seal is not flush to the pipe.**

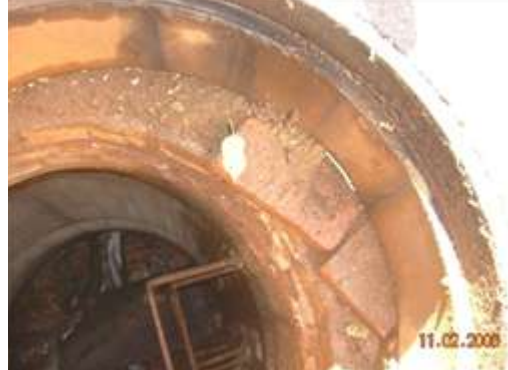
Defect

☒ **Leaks**

Condition: ☐ Sound ☐ Cracked ☐ Root Intrusion ☒ **Loose Brick** ☒ **Deteriorated**

Infiltration: ☐ None ☒ **Joint** ☐ Cracks ☒ **Mortar** ☐ Roots ☐ Wall

Frame leaks. Frame offset. Adjustment deterioration, loose brick and infiltration.

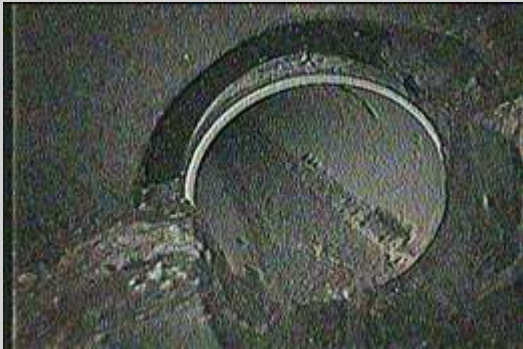
### 8 in. Circular Gravity Sewer Pipe Out @ 12 O'Clock

Invert Depth: **10.08** (ft.) Flow Characteristics: **Slow**

Infiltration: **None**

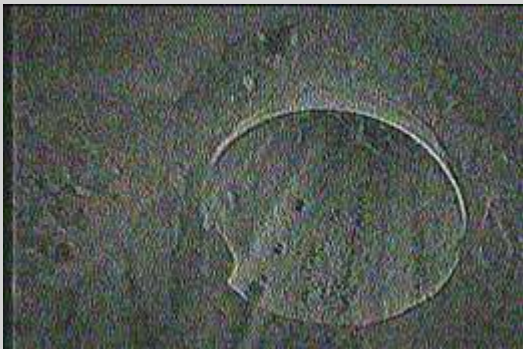
### 8 in. Circular Gravity Sewer Pipe In @ 6 O'Clock

Invert Depth: **9.96** (ft.) Flow Characteristics: **Slow**

Infiltration: **None**

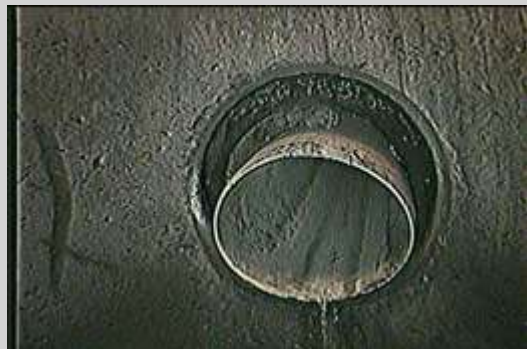
Pipe In @ 9 O'Clock

Invert Depth: **9.12** (ft.) Flow Characteristics: **Slow**

Infiltration: **None**
